TECHNICAL REPORT REMR-CO-3

CASE HISTORIES OF CORPS BREAKWATER
AND JETTY STRUCTURES

Report 7

NEW ENGLAND DIVISION

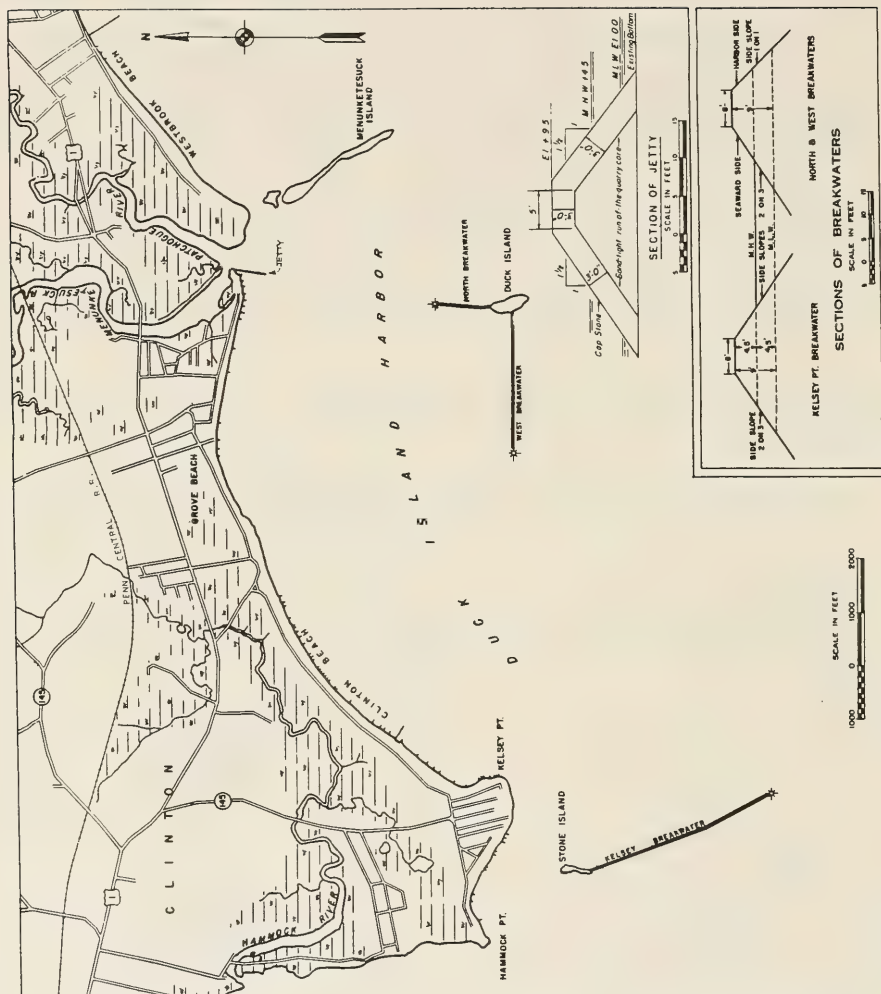
Figure 46. Location map and typical sections of Patchogue River Jetty and Duck Island Harbor breakwaters, Westport and Clinton, Conn.

1939	Repairs were made to the west and Kelsey breakwaters using 4,500 tons of stone for a total cost of \$25,600.
1962- 1977	Visual inspections showed the Duck Island breakwaters were in good condition while the Kelsey breakwater was rated from poor to good condition at various times. Subsequent repairs were performed.
1985	Yearly visual inspection of the structures revealed they were in good condition.
1986	Field surveys indicated the breakwaters were found to be in good condition.

<u>Date(s)</u>	<u>Construction and Rehabilitation History</u>
1956	A 600-ft-long rubble-mound jetty was constructed on the west side of the mouth of the Patchogue and Menunketesuck Rivers, providing protection to the 8-ft-deep Patchogue entrance channel (Figure 46). The design section consisted of a +9.5 ft mlw crown elevation, a 7-ft crown width, and 1V:1.5H side slopes. The jetty was built with a sand-tight core of 3-in. to 200-lb stone and covered with a 3-ft-thick layer of 1- to 6-ton stone. The cost for placing 6,470 tons of stone was \$45,100.
1962- 1977	Visual inspections indicated the jetty was in excellent condition.
1985	Annual visual inspections of the jetty indicated it was in good condition.

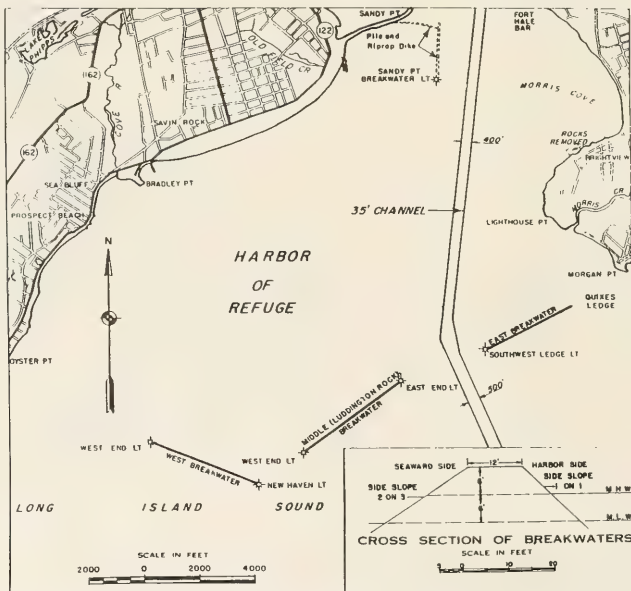
Figure 47. Breakwaters at New Haven Harbor of Refuge, Conn.

Date(s)	Construction and Rehabilitation History
1880-1915	Three rubble-mound breakwaters were constructed as part of the Harbor of Refuge at New Haven (Figure 47). The breakwaters were constructed to a crown elevation of +12 ft mlw, a 12-ft crown width, and slopes of 1V:1H and 1V:1.5H on the harbor and sea sides, respectively. The 3,450-ft long east breakwater was built during 1880-90 using 293,800 tons of stone and repaired in 1911 using 2,900 tons of stone. The 4,500-ft-long middle breakwater was built during 1891-96 using 339,000 tons of stone and repaired in 1911 and 1915 using 10,600 and 12,000 tons of stone, respectively. The 4,200-ft-long west breakwater was built during 1896-97 and 1907-11 using 478,100 tons of stone and repaired in 1915 using 14,300 tons of stone. The breakwater's construction costs during this period were approximately \$1,120,000.
1935	The breakwaters were repaired using 6,720 tons of stone for a total cost of \$18,500.

1960-1974	The breakwaters were considered to be in fair to good condition during several visual inspections taken over this period.
1984	Yearly visual inspection of breakwaters indicated they were in good condition.

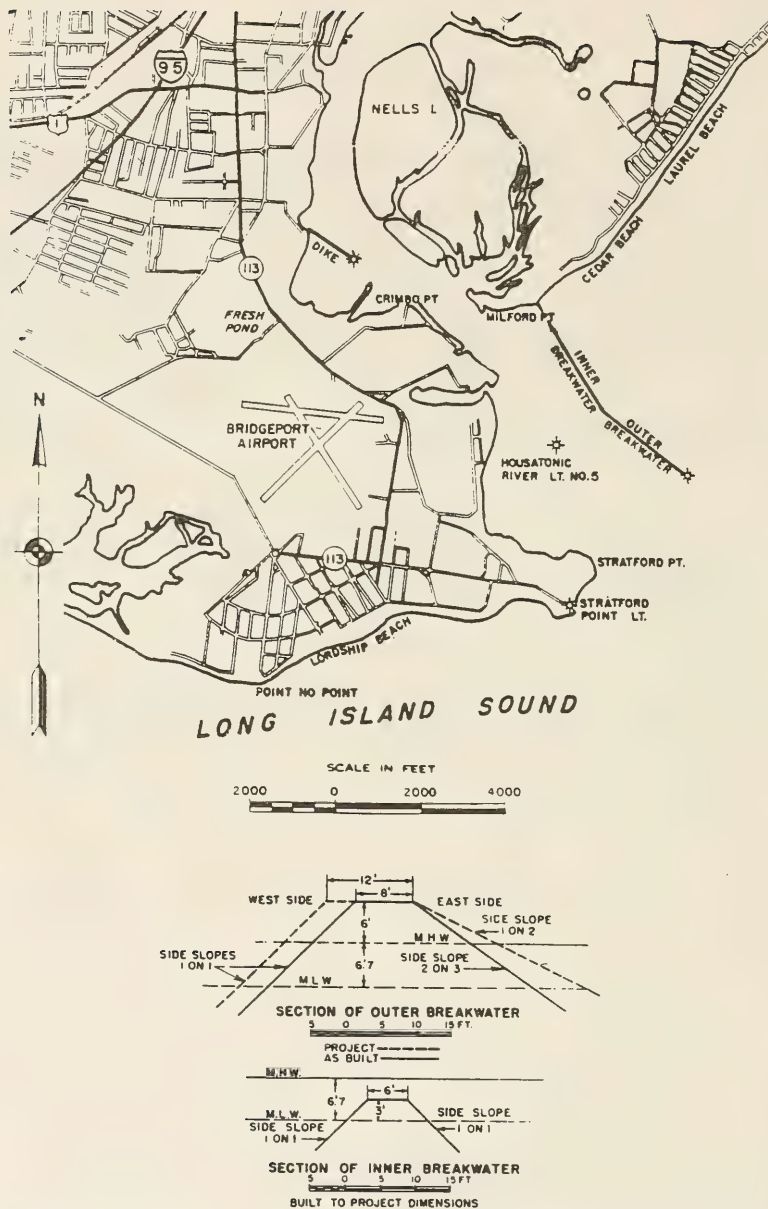
Figure 49. Plan view and cross sections of breakwater at the mouth of the Housatonic River, Conn.

<u>Date(s)</u>	<u>Construction and Rehabilitation History</u>
1889- 1895	The inner and outer arms of the Housatonic breakwater (Figure 49), 3,250 and 2,570 ft long respectively, were constructed using 12,500 and 44,560 tons of stone, respectively. The inner arm was built to approximately mid-tide level with a crown elevation of +3 ft mlw, a 6-ft crown width, and 1V:1H side slopes. The outer arm was constructed to a crown elevation of +12.7 ft mlw, and 8-ft crown width, and slopes of 1V:1H and 1V:1.5H on the channel and sea sides, respectively. The construction costs totaled approximately \$75,000.
1905- 1906	Repairs were made to both arms of the breakwater using a total of 3,990 tons of stone.
1911- 1916	During this period, the outer breakwater arm was extensively repaired using a total of 16,200 tons of stone. The crest width was increased to 12 ft, and side slopes of 1V:2H were placed on the sea side. In 1914, the inner arm was repaired using 1,000 tons of stone. Total repair costs were \$26,200.

1940- 1941	The outer arm was repaired using 1,350 tons of stone for a cost of \$6,700.
1960- 1977	Visual inspections showed the outer arm was in good condition, and only minor repairs were needed at the seaward end. The inner arm was in poor condition and needed repairs throughout its length.
1986	The present condition of the breakwater is not known.

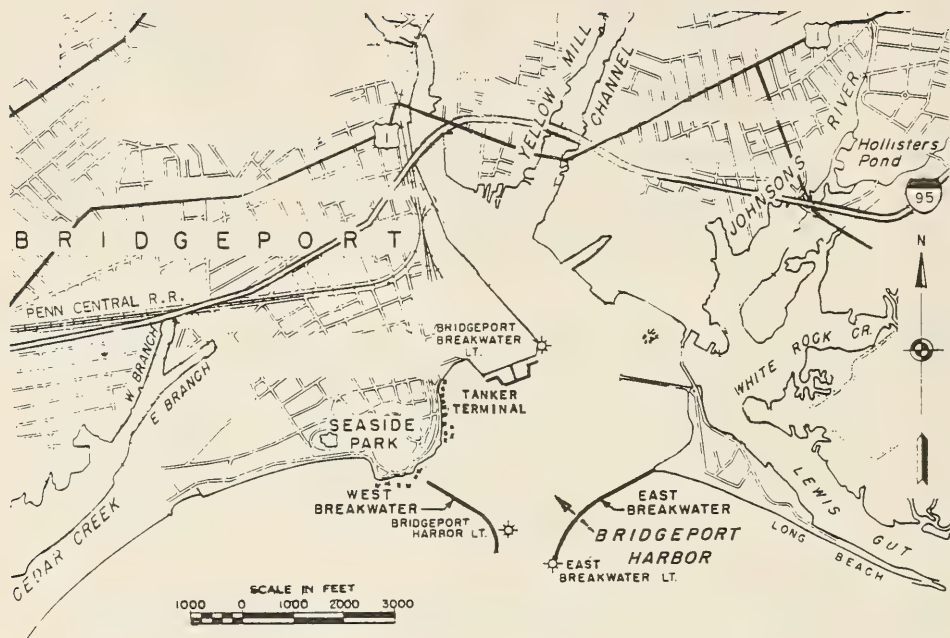
Figure 50. Breakwaters at Bridgeport Harbor, Conn.

<u>Date(s)</u>	<u>Construction and Rehabilitation History</u>
1871- 1973	The Bridgeport Harbor east breakwater was built to a length of 1,380 ft (Figure 50).
1900	The east breakwater was extended 380 ft using 5,080 tons of stone for a total cost of \$10,200.
1907- 1908	The east breakwater was extended to a total length of 3,823 ft using 43,560 tons of stone. The completed breakwater cross section consisted of a +9.5 ft mlw crown elevation, an 8-ft crown width, and slopes of 1V:1H and 1V:1.5H on the harbor and sea sides, respectively. Total cost of placing 43,560 tons of stone in the extension was \$51,000.
1908- 1909	The west breakwater was constructed to a length of 2,110 ft using 39,290 tons of stone for a total cost of \$46,000. The design section was identical to that of the east breakwater, except for the crown width which was 6 ft.
1935	The breakwaters were repaired for a total cost of \$12,500. Stone quantities placed on the east and west breakwaters were 3,300 and 1,170 tons, respectively.

1941	The east breakwater was repaired using 2,650 tons of stone for a total cost of \$13,000.
1960- 1978	Several visual inspections were made, and the breakwaters were generally in good condition. By 1978 the inspectors recommended the structures be considered for future maintenance.
1986	Present conditions of the breakwaters are not known.

Date(s)	Construction and Rehabilitation History
1951	An 800-ft-long sand-tight jetty was constructed on the west side (Jennings Beach) of the mouth of Ash Creek (Figure 50). The jetty cross section consisted of a +9 ft mhw crown elevation, a 5-ft crown width, and side slopes of 1V:1.5H. The jetty had a run of quarry core and a 3-ft-thick double layer of cover stone (size not known). The jetty was built by local interests who were reimbursed one-third the first cost of construction by the Federal government.
1986	The jetty has no known repair history, and its present condition is not known.

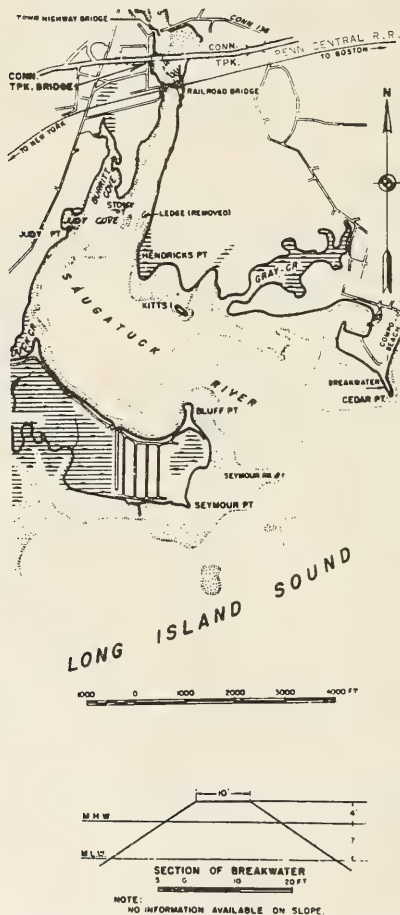
Figure 53. Cedar Point breakwater, mouth of the Saugatuck River, Conn.

<u>Date(s)</u>	<u>Construction and Rehabilitation History</u>
1896	A 600-ft-long rubble-mound breakwater was constructed on the east side of the Saugatuck River's mouth (Figure 53). The crown elevation and width were +11 ft mhw and 10 ft, respectively.
1986	The breakwater has no known repair history, and its present condition is unknown.

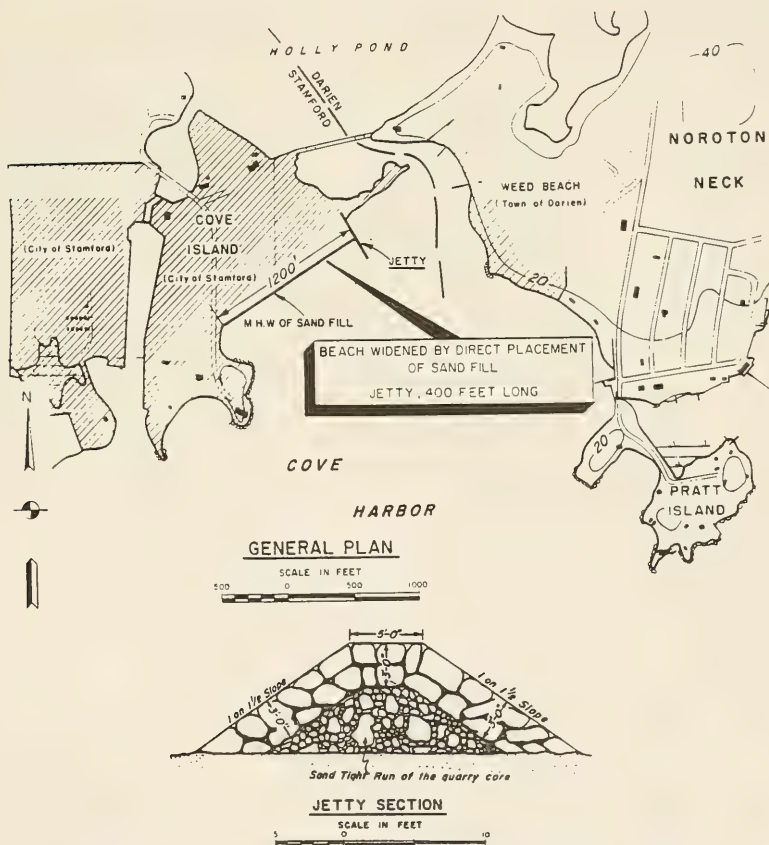
Figure 54. Cove Harbor Jetty, Cove Island, Conn.

Date(s)	Construction and Rehabilitation History
1958	A 400-ft-long jetty was constructed on the east side of Cove Island (Figure 54). The jetty consisted of a +10 ft crown elevation, a 5-ft crown width, 1V:1.5H side slopes, a sand-tight run of quarry core, and a 3-ft-thick double layer of cover stone. The State of Connecticut, which constructed the jetty, was reimbursed by the Federal government for one-third of the project cost.
1986	The jetty has no known repair history, and its present condition is unknown.

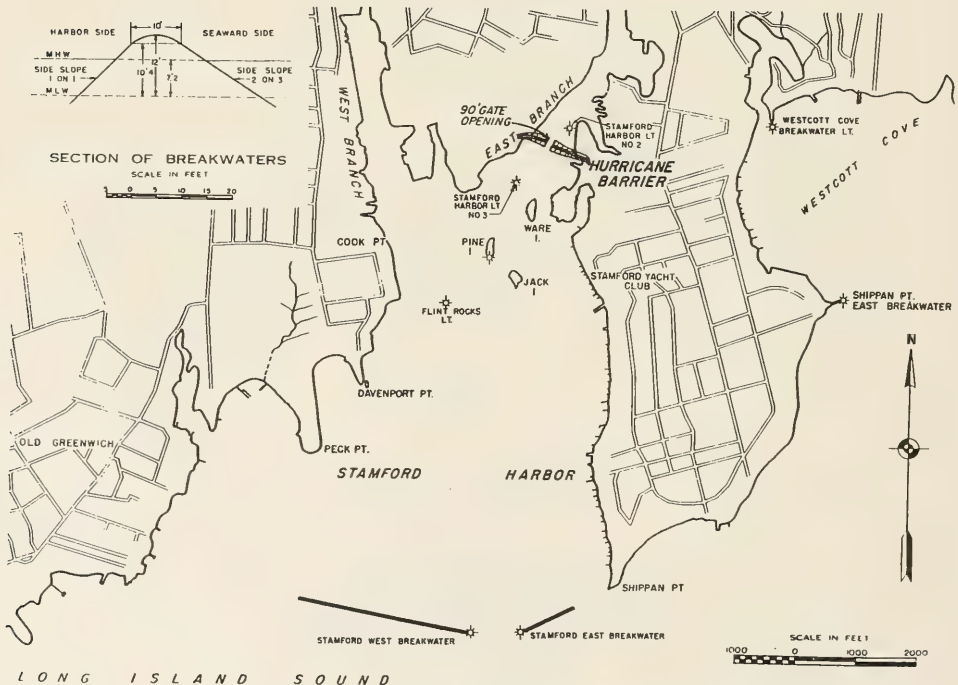
Figure 55. Plan view of breakwaters at Stamford Harbor, Conn.

<u>Date(s)</u>	<u>Construction and Rehabilitation History</u>
1940-1941	The east and west breakwaters (Figure 55) were constructed to lengths of 1,200 and 2,900 ft, respectively, using 40,100 and 118,100 tons of stone, respectively. The cross section had a maximum crown elevation of +12 ft mlw, a 10-ft crown width at +10.4 ft mlw, and slopes of 1V:1H and 1V:1.5H on the harbor and sea sides, respectively. The total construction cost was \$398,900.
1960-1977	Visual inspections indicate the breakwaters were in fair to good condition.
1986	Present conditions of the breakwaters are not known.
